SUBJECT: Results of Year 6 Operations, Maintenance, and Monitoring Plan Site Activities; Head of the Thea Foss Waterway Remediation, Tacoma, WA

Date: June 3, 2010
To: Jacqueline Thiell Wetzsteon, PacifiCorp
From: Benjamin Starr *Benjamin I. Starr* and Gary Braun *Gary Braun*
RE: Low Tide Site Observations and Maintenance
April 19, 2010
Head of the Thea Foss Waterway Project

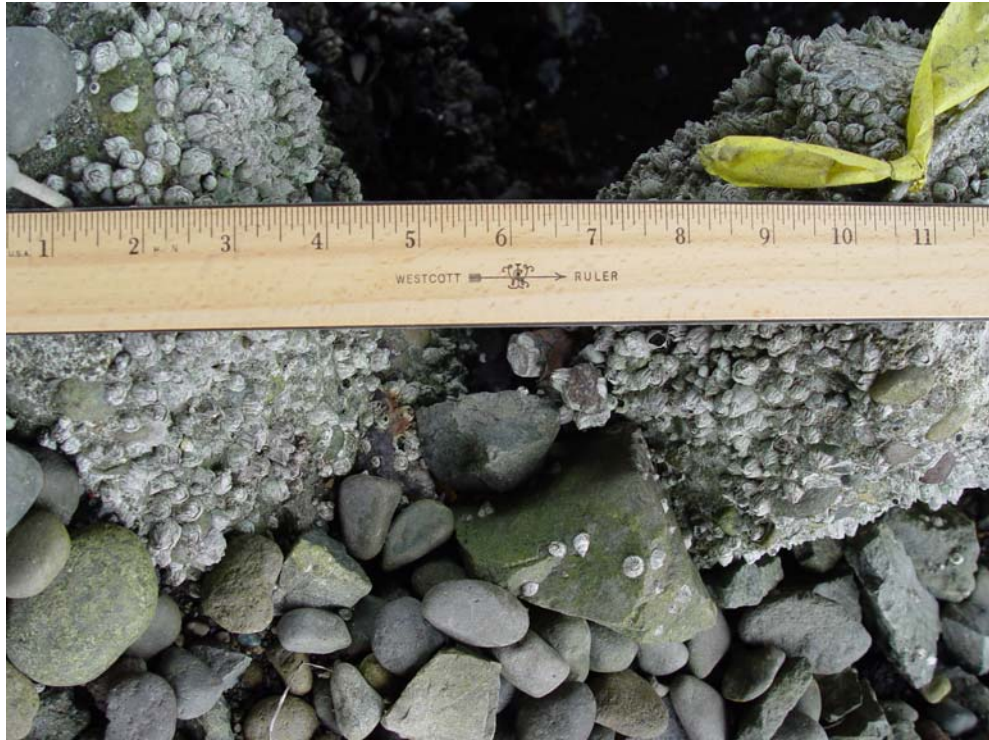
At Outfall 235, both wing walls are separating from the Outfall 235 head wall. At the low-tide site-walk conducted in May 2008 (Year 4 OMMP), it was observed that the City of Tacoma had installed PK nails on the north and south ends of the top of the headwall and on the west ends of the north and south wing walls to enable monitoring of any movement between the headwall and the wing walls. The separation between the head wall and the south wing wall is larger than the separation between the head wall and the north wing wall. The distances measured during this site visit between the sets of PK nails were approximately 9 1/2 inches and 7 3/4 inches respectively, slightly greater than the distances measured during Year 5 observations (9 3/8

inches and 7 1/2 inches respectively) (Figures 1 and 2). Some loss of habitat mix material from slopes adjacent to the wing walls through the cracks in the wing walls was observed.

Figure 1 – Outfall #235 south wingwall separation

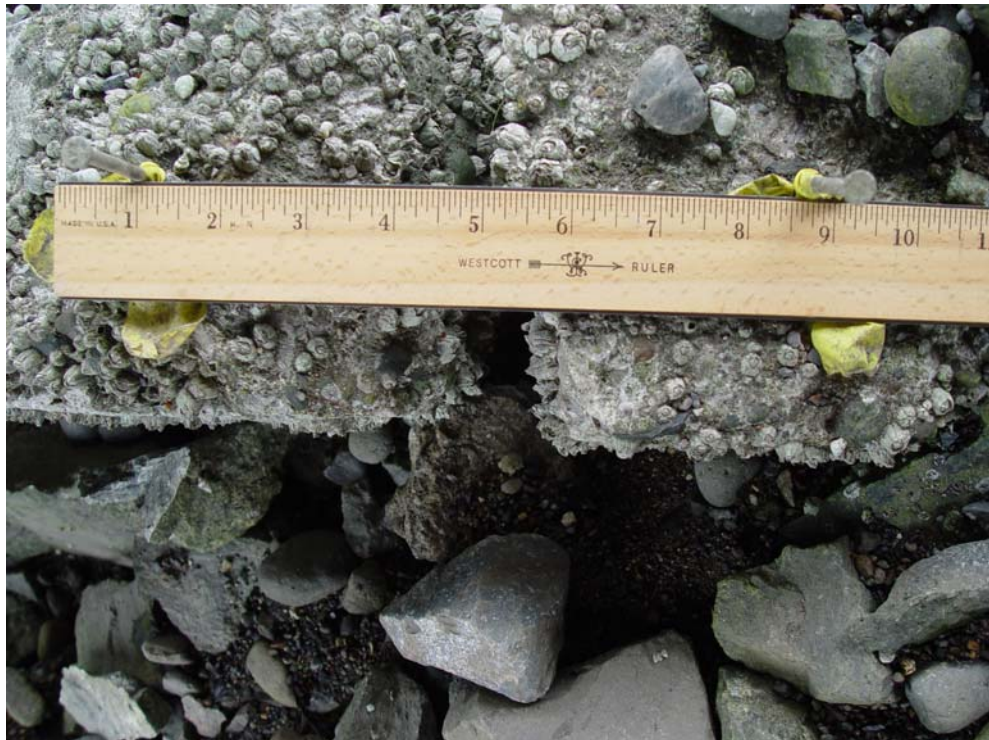
Figure 2 – Outfall #235 north wingwall separation

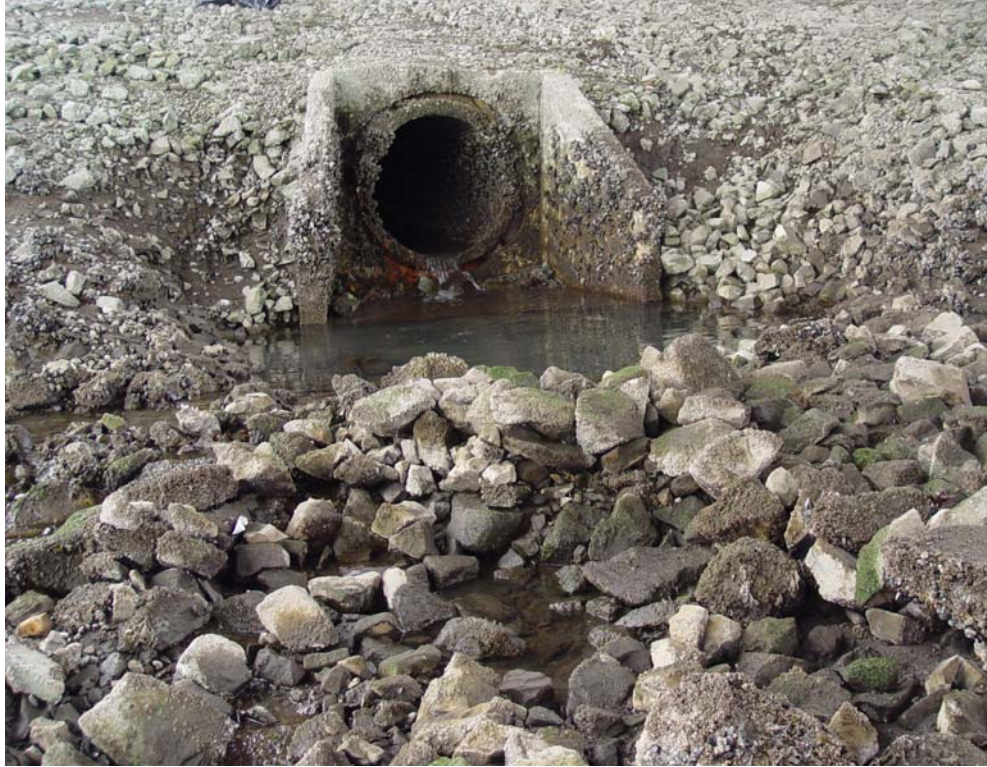
As noted during the Year 5 OMMP low tide site observations and documented in Tetra Tech's August 28, 2009 Technical Memorandum, the scour protection adjacent to Outfall 235 (at Station 73+20 on the west side of the waterway under the SR-509 bridge) appeared to have been intentionally displaced directly in front of the outfall to make a pool with a sandy bottom, possibly for bathing as there was evidence that there are displaced persons living in the immediate area. The slope armor adjacent to both the south and north wing walls was observed to have been displaced or sloughed, leaving the underlying slope cap exposed (Figures 3 -5). It is believed the intentional displacement of the outfall scour material in front of Outfall 235 and from the toe of adjacent slopes contributed to instability and caused downward movement of armor material from the slope areas. As a result, the underlying slope cap became exposed and potentially subject to erosion. The Year 5 OMMP Technical Memorandum recommended restoration of the outfall scour protection to ensure the integrity of the underlying slope cap. At the time of the site visit in April 2010 (Year 6), the area of exposed slope cap adjacent to both the south and north wing walls appears slightly greater than was observed during Year 5 OMMP (Figures 3 through 5).

Figure 3 – Looking at Outfall #235 prior to maintenance activities

Armor stones that had been removed from in front of the outfall to make room for a sandy pool were restacked adjacent to each side of the outfall. Larger stones were stacked at the toe of the slope, to create a small retaining berm. Smaller stones were stacked behind this berm, extending up the slope on either side of the outfall. As stones were removed from an approximately half-moon shaped ring at the perimeter of the pool, it was observed that the stones had been stacked in alternating layers with pieces of clothing and debris, further corroborating the supposition that armor stone had been intentionally displaced. Figures 3 through 5 illustrate the sloughed areas before maintenance activities were conducted. Figure 6 shows the results of the successful maintenance activities and documents the condition of these areas once the armor stone had been replaced. The slope areas adjacent to Outfall #235 will be monitored during future OMMP events to observe the condition of the armor and underlying slope cap.

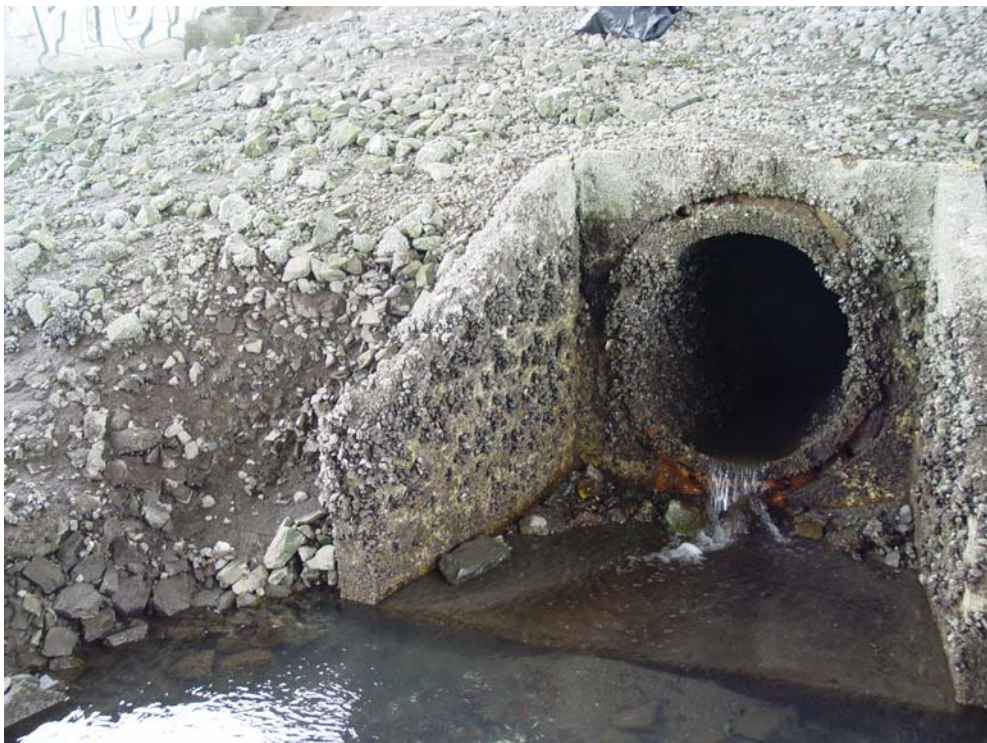
Figure 4 – Looking at south side of Outfall #235 prior to maintenance activities

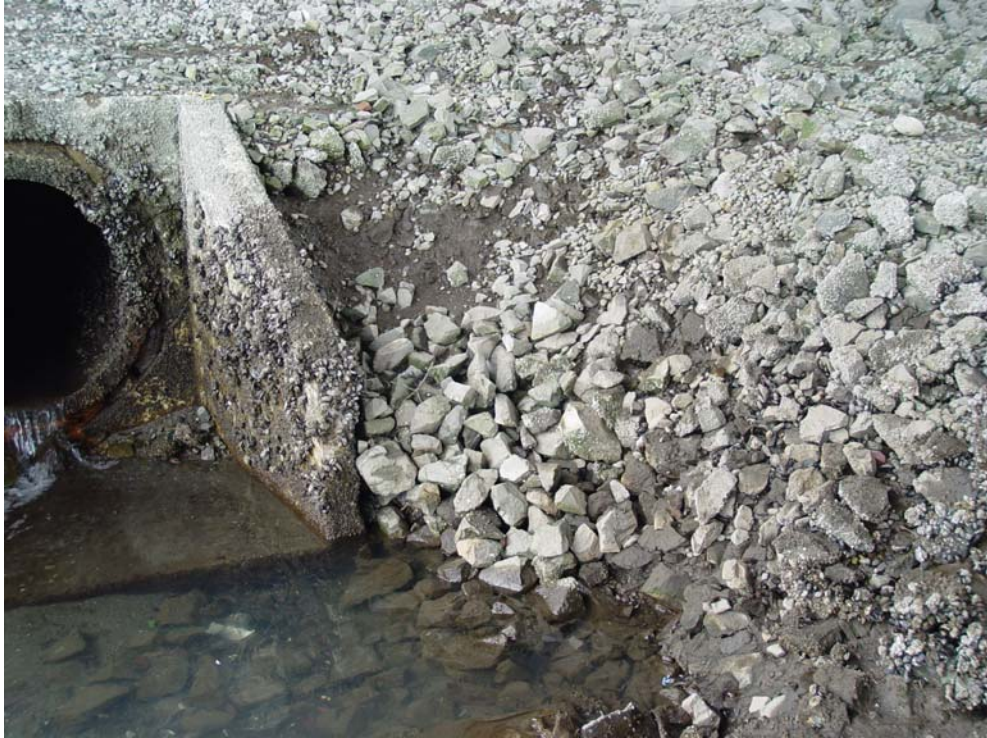
Figure 5 – Looking at north side of Outfall #235 prior to maintenance activities

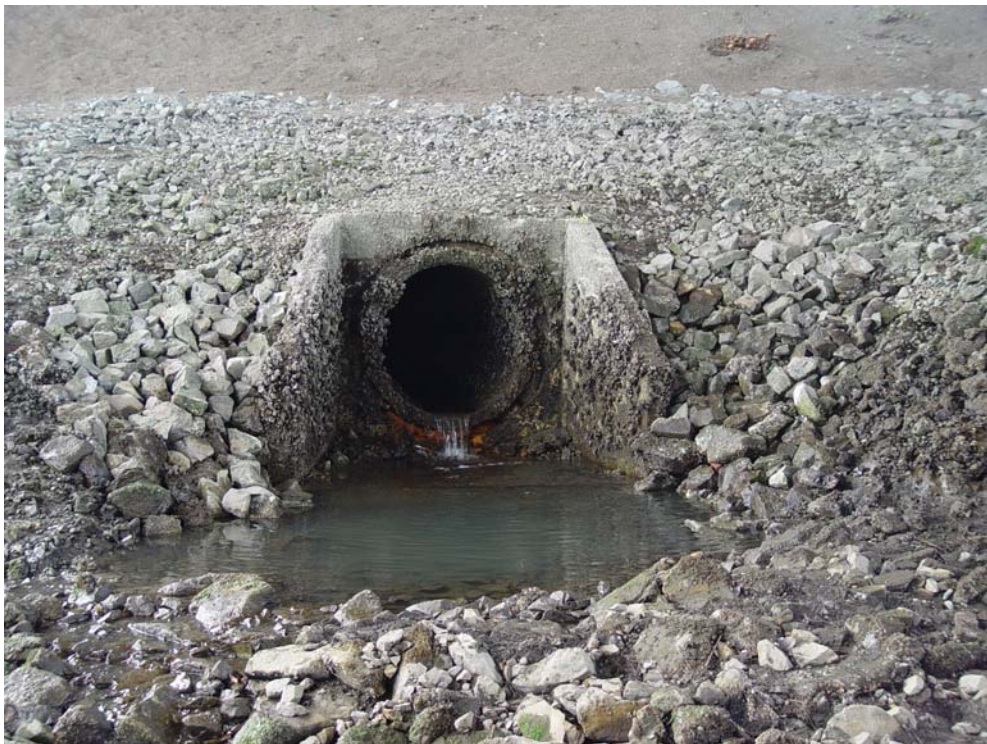
Figure 6 – Looking at Outfall #235 following maintenance activities

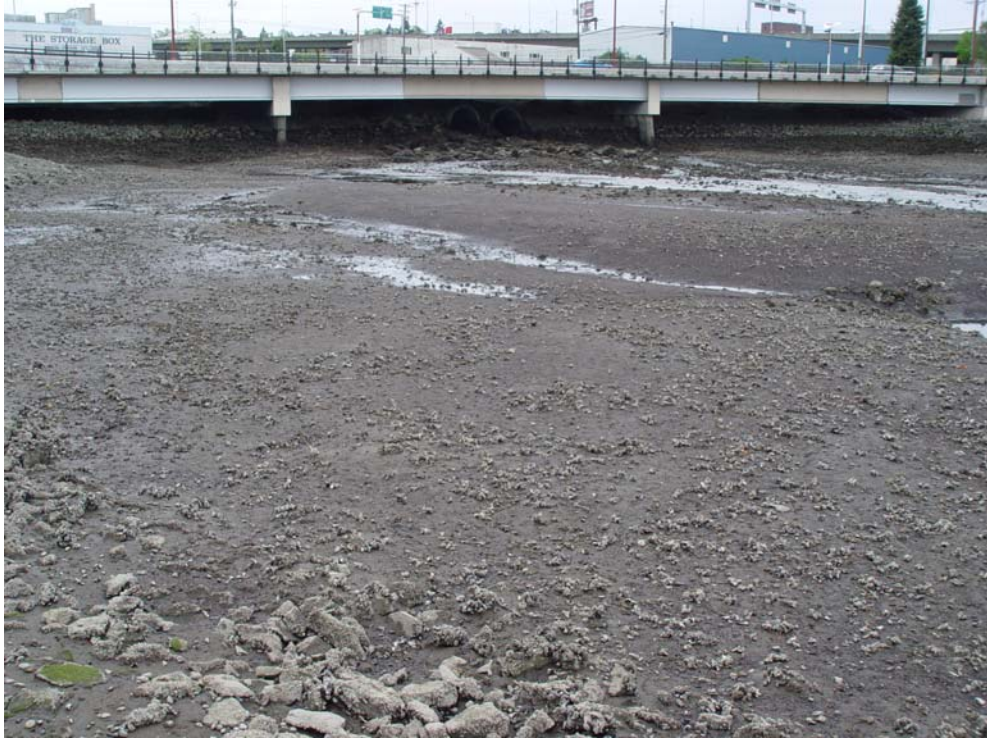
The condition of the scour protection apron at the south end of the waterway was consistent with observations presented in the Year 5 OMMP Technical Memorandum. Water was flowing out of Outfalls 237a and 237b during the site visit. Discharge from these outfalls was spreading out over the apron and flowing northward towards the turning basin. As previously noted in the Years 0 through 5 low tide site observations, a small, shallow channel is present in the apron near the southeast corner of the waterway. The configuration and shallow depth of this channel appear unchanged from previous observations and the overall integrity of the cap has not been adversely impacted by the presence of this localized feature. Slight foaming was observed in the water discharging from the twin 96-inch outfalls; no sheen was observed.

Figure 7 – Looking southwest at scour apron at the head of the waterway

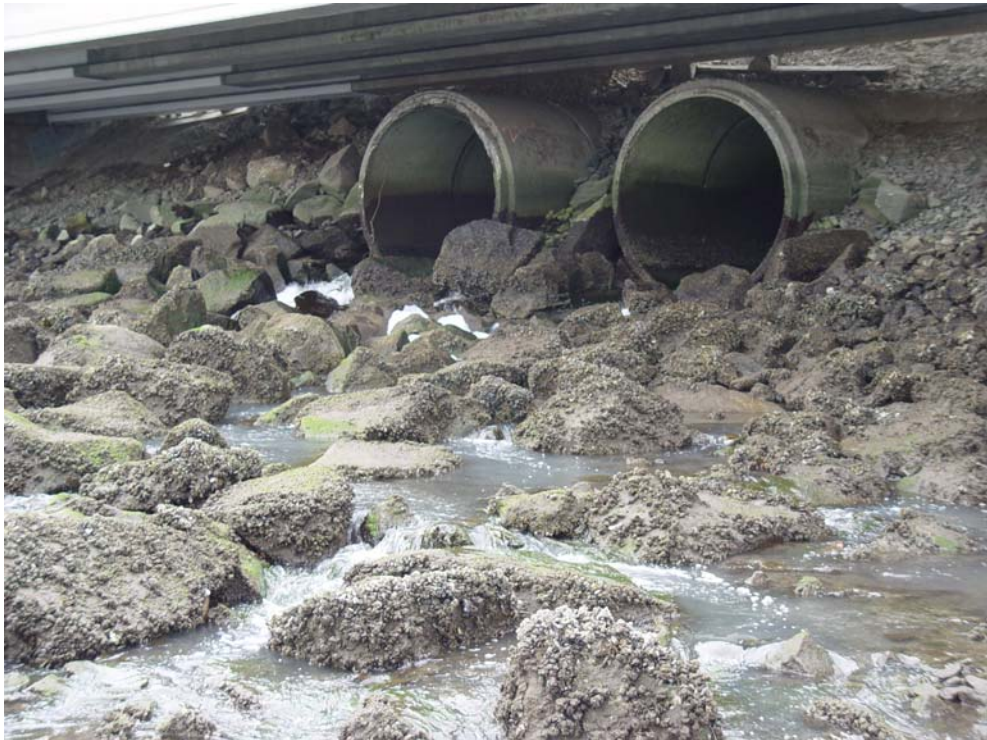
Figure 8 – Looking south at twin 96-inch outfalls – Outfalls 237A and 237B

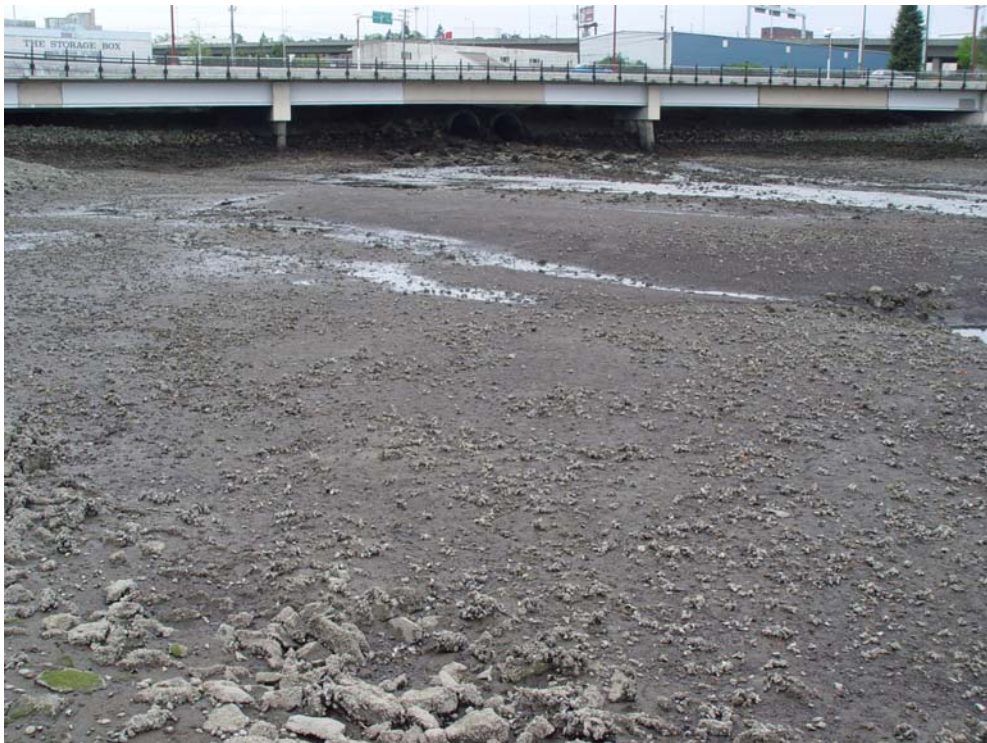
Figure 10 – Looking south at flow from twin 96-inch outfalls

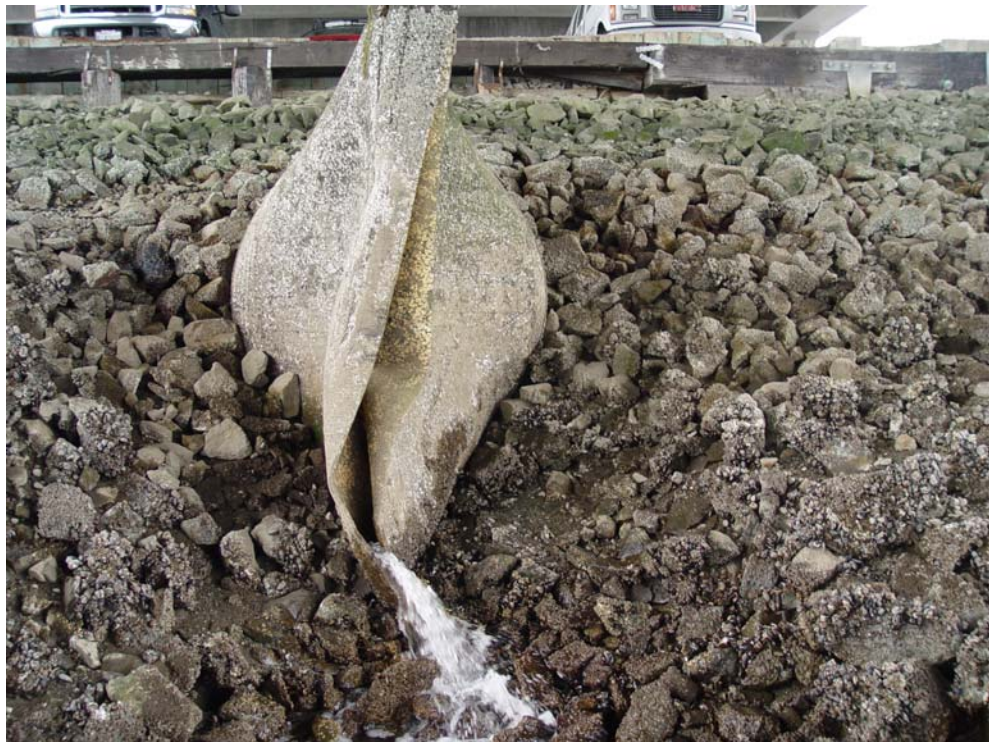
- The scour protection adjacent to Outfall 243 (at Station 73+40 on the east side of the waterway under the SR-509 Bridge) shows no further signs of erosion or displacement. A small flow of water was exiting the Outfall 243 during the site visit. The Tideflex™ valve at the end of Outfall 243, which was extensively covered with barnacles and mussels at the time of the year 5 observations, appears to have been cleaned.

Figure 12 – Outfall #243 on east side of waterway under the SR-509 Bridge

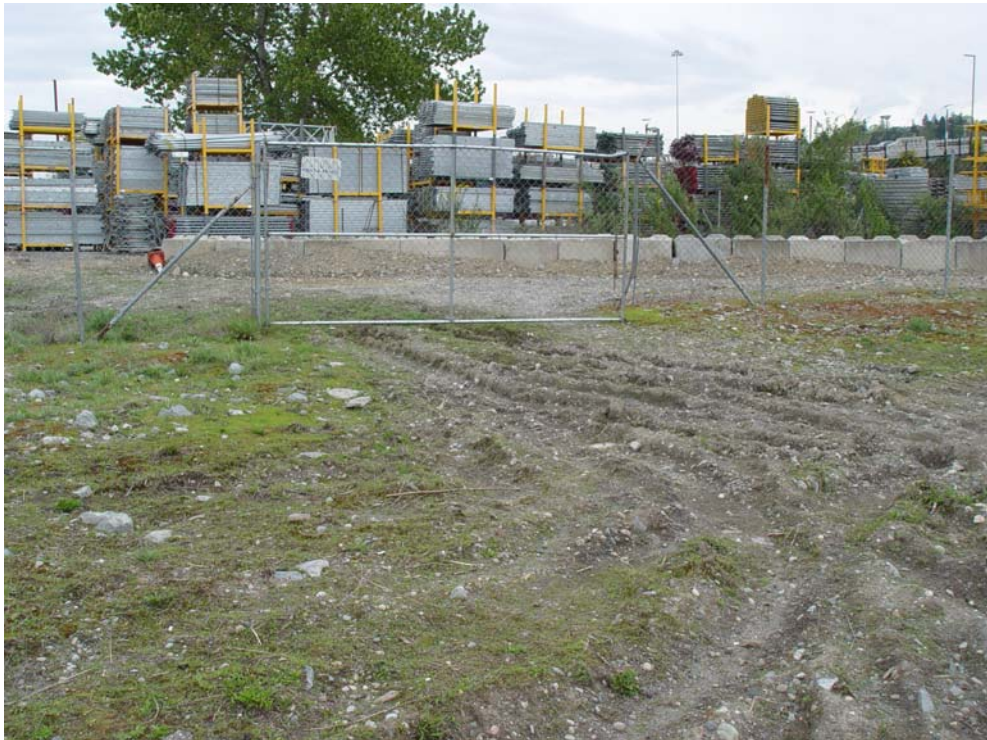
- At the scaffolding company property on the east side of the waterway, a new fence and combination ecology block and sand berm was observed. This appeared to be a stormwater best management practice that had been recently implemented.

Figure 14 – Looking east along the east slope of the waterway towards scaffolding company. Note recent ecology block and sand berm.

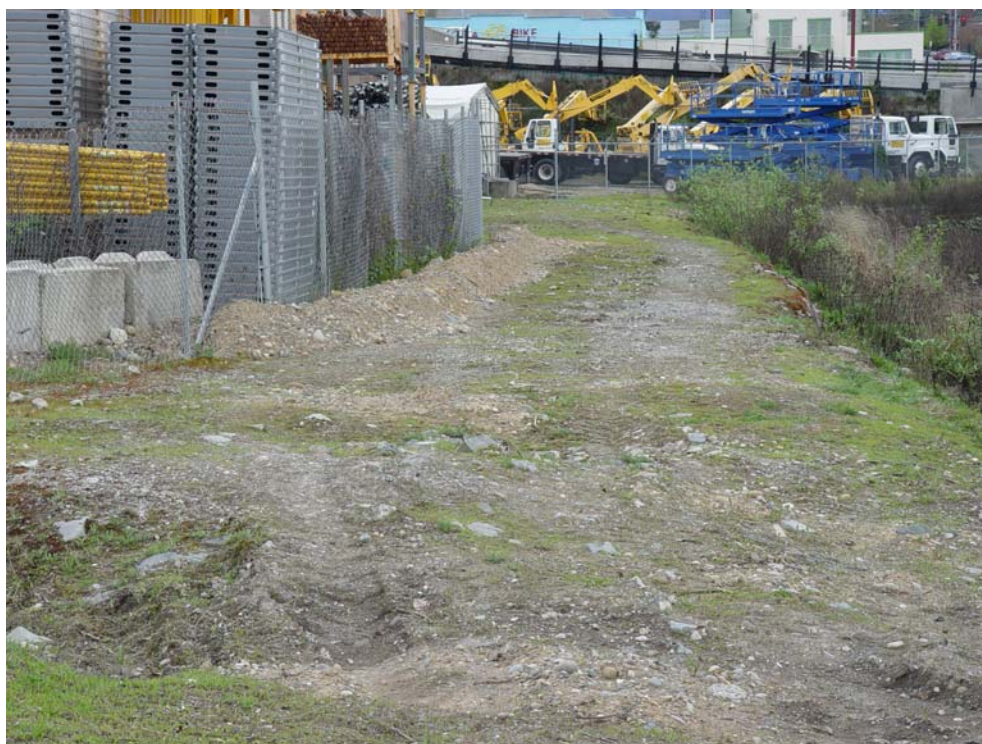
Figure 15 – Looking south along the east slope of the waterway, adjacent to scaffolding company. Note recent ecology block and sand berm.

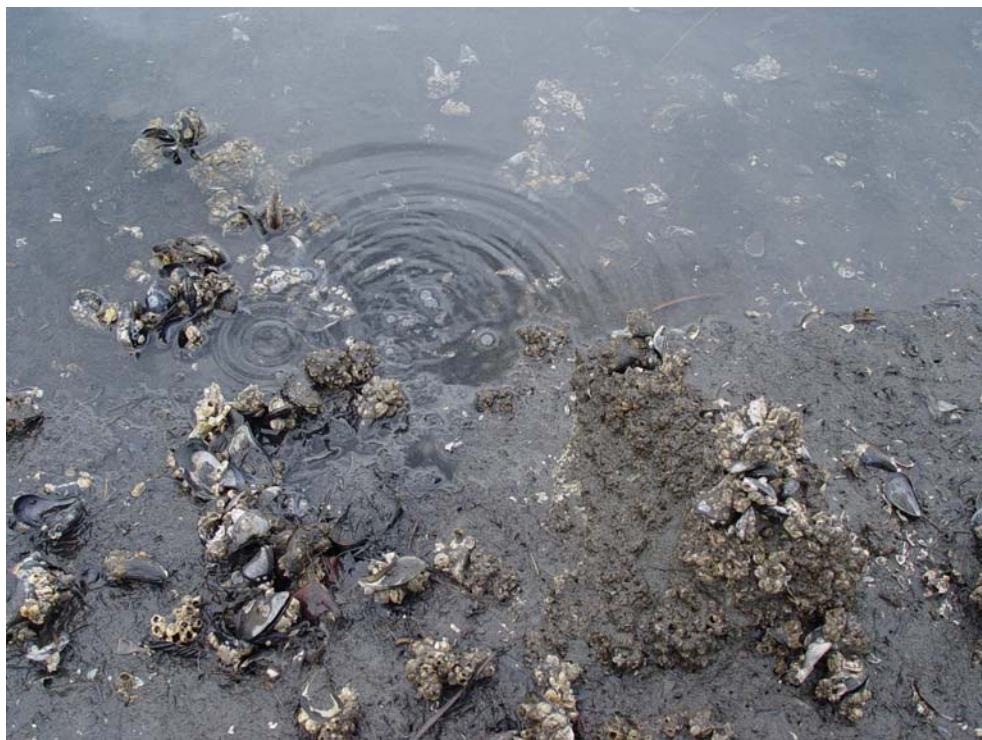
- The weather was partly cloudy, and temperature in the mid- 50s during this field visit.
- Gas bubbling was observed throughout the head of the waterway but no sheens were observed.

Figure 16– Gas bubbles emanating from sediment. East side of waterway, adjacent to scaffolding company property

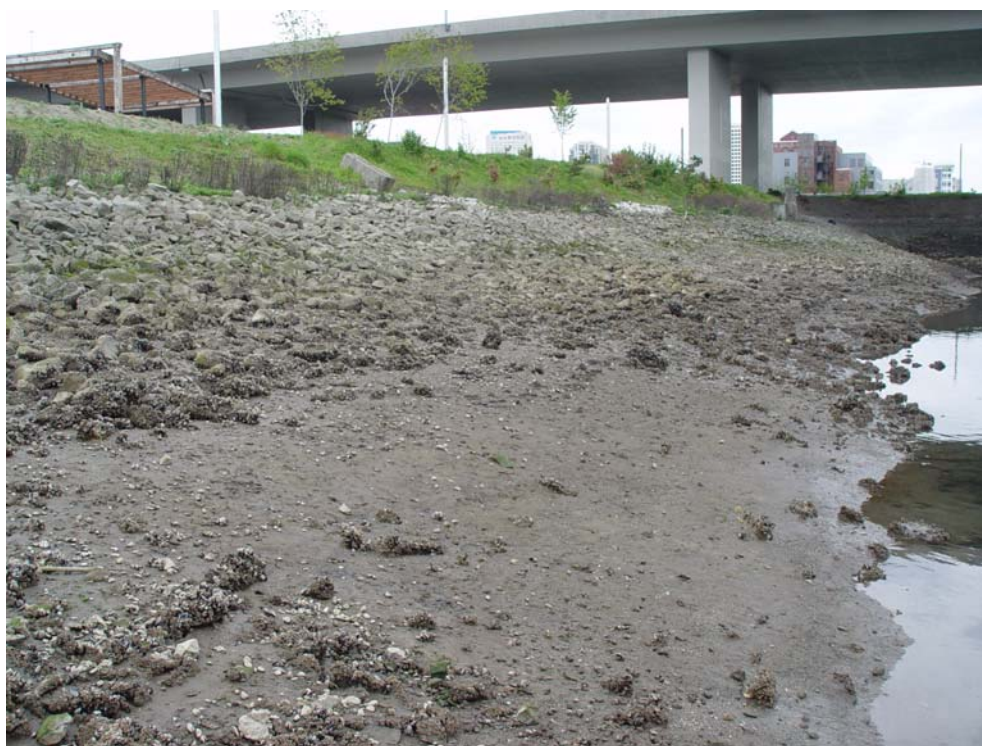
No slope erosion or sloughing was observed. As previously noted in the Years 0 through 5 site observation memoranda, the coarser slope cap materials was covered with algae, seaweed, and barnacles. Mussels were also present on these materials. A layer of olive and gray silt was present over capping material on the lower portions of the east and west bank slopes.

Figure 17– Looking north along the west slope of the Waterway
